Field Report  
Avery Landing  
Avery, Idaho

September 19, 2006

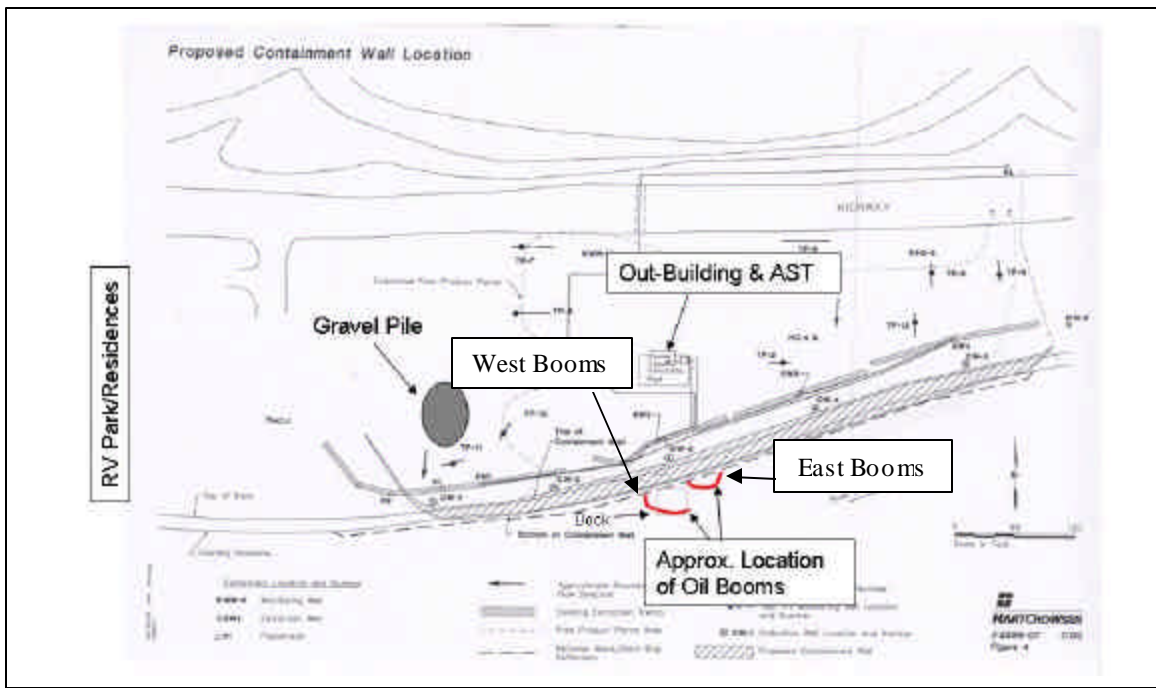
Figure 5. Approximate location of oil booms

East Booms - There is a heavy sheen on the water with color grading from iridescent to gray. Sheen appears from heavy oil, distinct globules form in some areas. There is some oil leaking from boom containment.

West Booms – There is slight sheen with grayish color, distinct globules form in some areas. Some adsorbent pads have also been deployed
